Test Report

No. SHAEC1903015401

The following sample(s) was/were submitted and identified on behalf of the clients as : Bottled Water System

Model No. : USS-FBW00001

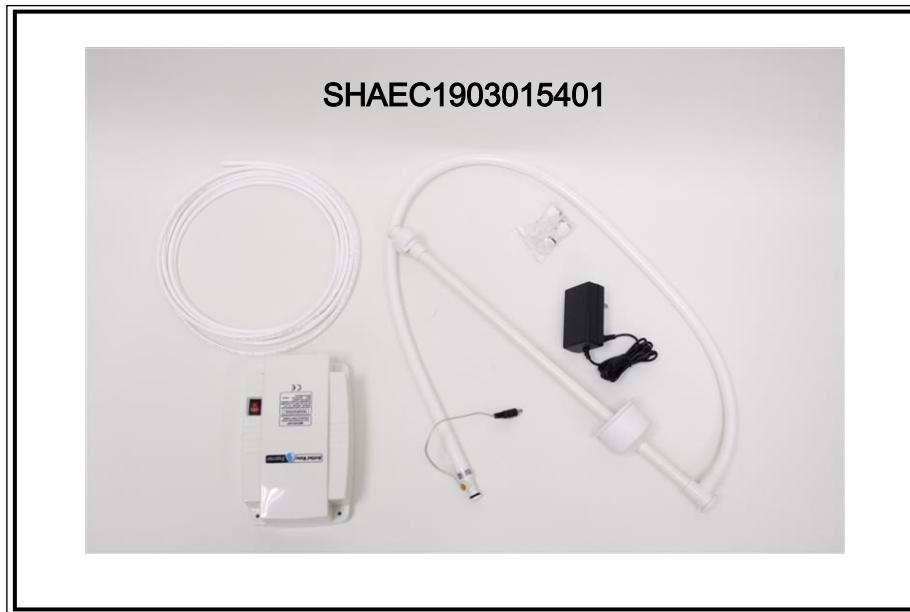
Sample photo:

Specimen No.	SGS Sample ID	Description
SN1	SHA19-030154.001	White tube part
